# LIMITED ASBESTOS AND LEAD-BASED PAINT ASSESSMENT STUDY

## BRIDGE N108

## TOHATCHI, NEW MEXICO 87325

July 19, 2021

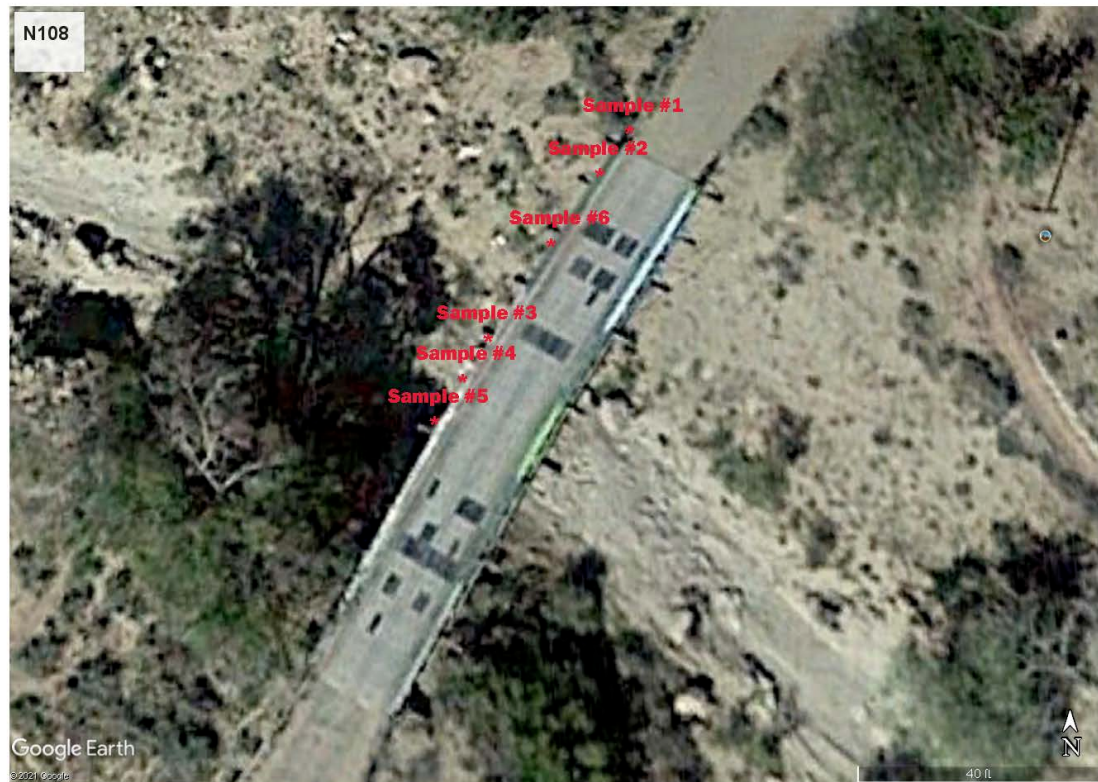
*Figure 1*

LBP was identified at the subject structure. Locations of the sampled areas are shown on Figure 1. NV5, Inc. recommends management of the lead-based paint materials during demolition in accordance with NMED guidelines. Any contractor disturbing lead containing materials must comply with OSHA 29 CFR 1926.62 Lead in Construction Standard. LBP-containing materials must also be properly disposed according to New Mexico landfill requirements.

**Sample locations 1-6**

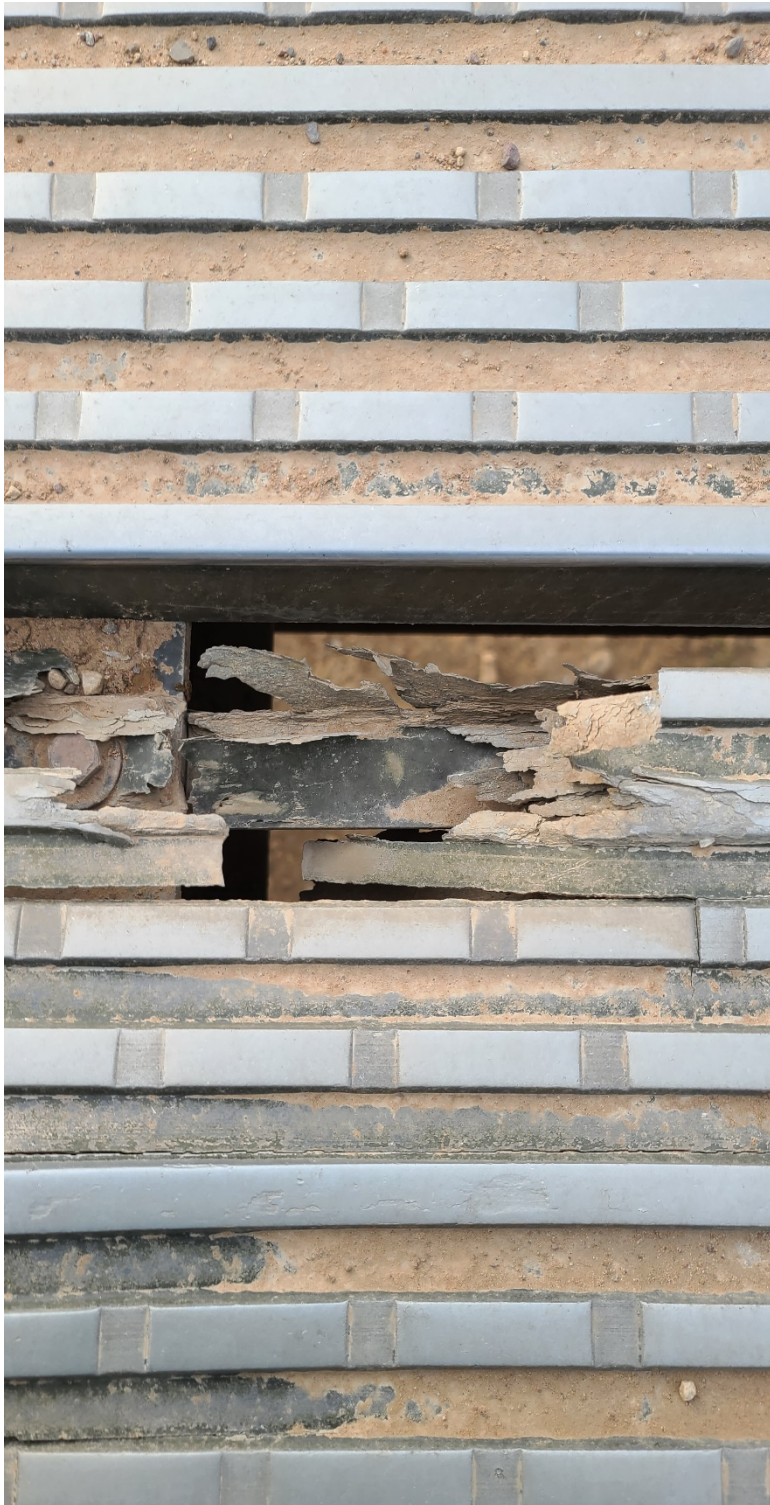
Three (3) samples of suspected ACBM were taken from the damaged deck plates interior that were exposed. Analytical Test results did not detect the presence of ACBMs.

Three (3) samples of suspected ACBM were taken from the damaged deck plates interior that were exposed. Suspect material is layered within the aluminum deck plates. Most of the road surface is comprised of these plates, except for those that have been replaced with flat steel plates. There was no evidence of the removed/replaced plates onsite.

Bridge deck plates - damaged, with interior material degrading

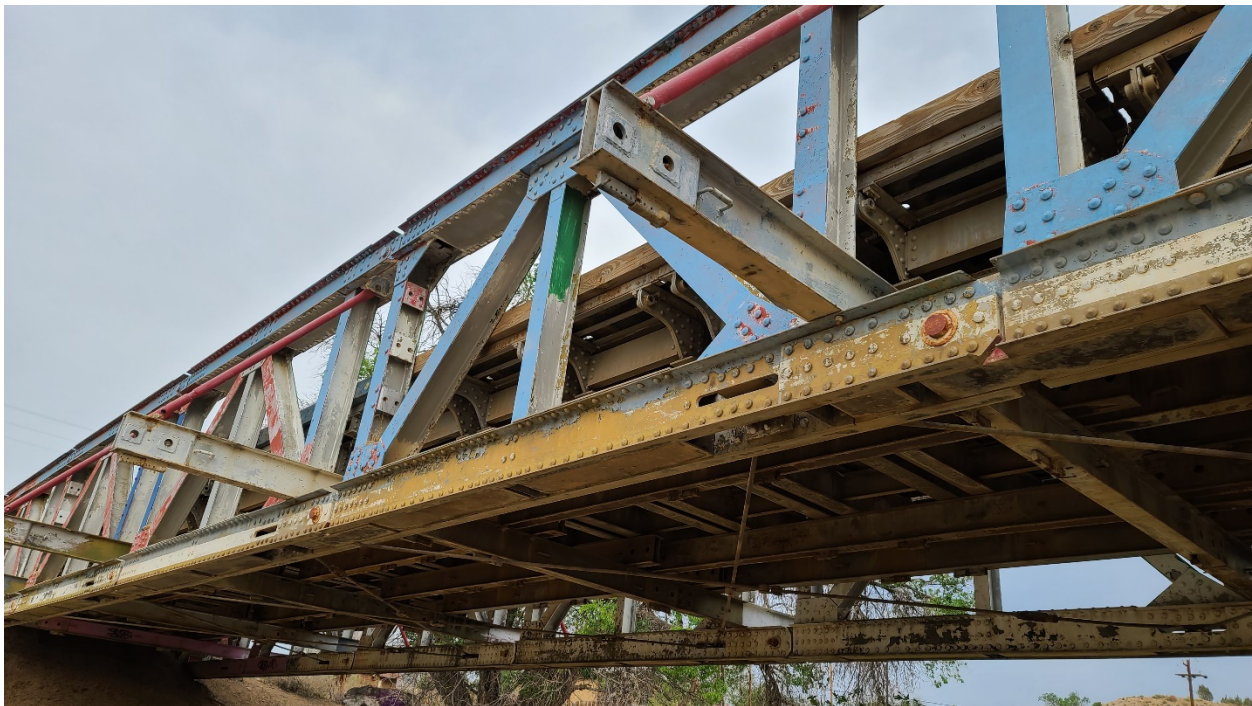
Four of the six paint samples identified materials with LBP. These painted surfaces were semi-intact and were flaking. NV5, Inc. does not recommend further sampling for LBP.

East side showing paint flaking off.

NV5, Inc. recommends management of the lead-based paint materials during demolition in accordance with NMED guidelines. Any contractor disturbing lead containing materials must comply with OSHA 29 CFR 1926.62 Lead in Construction Standard.

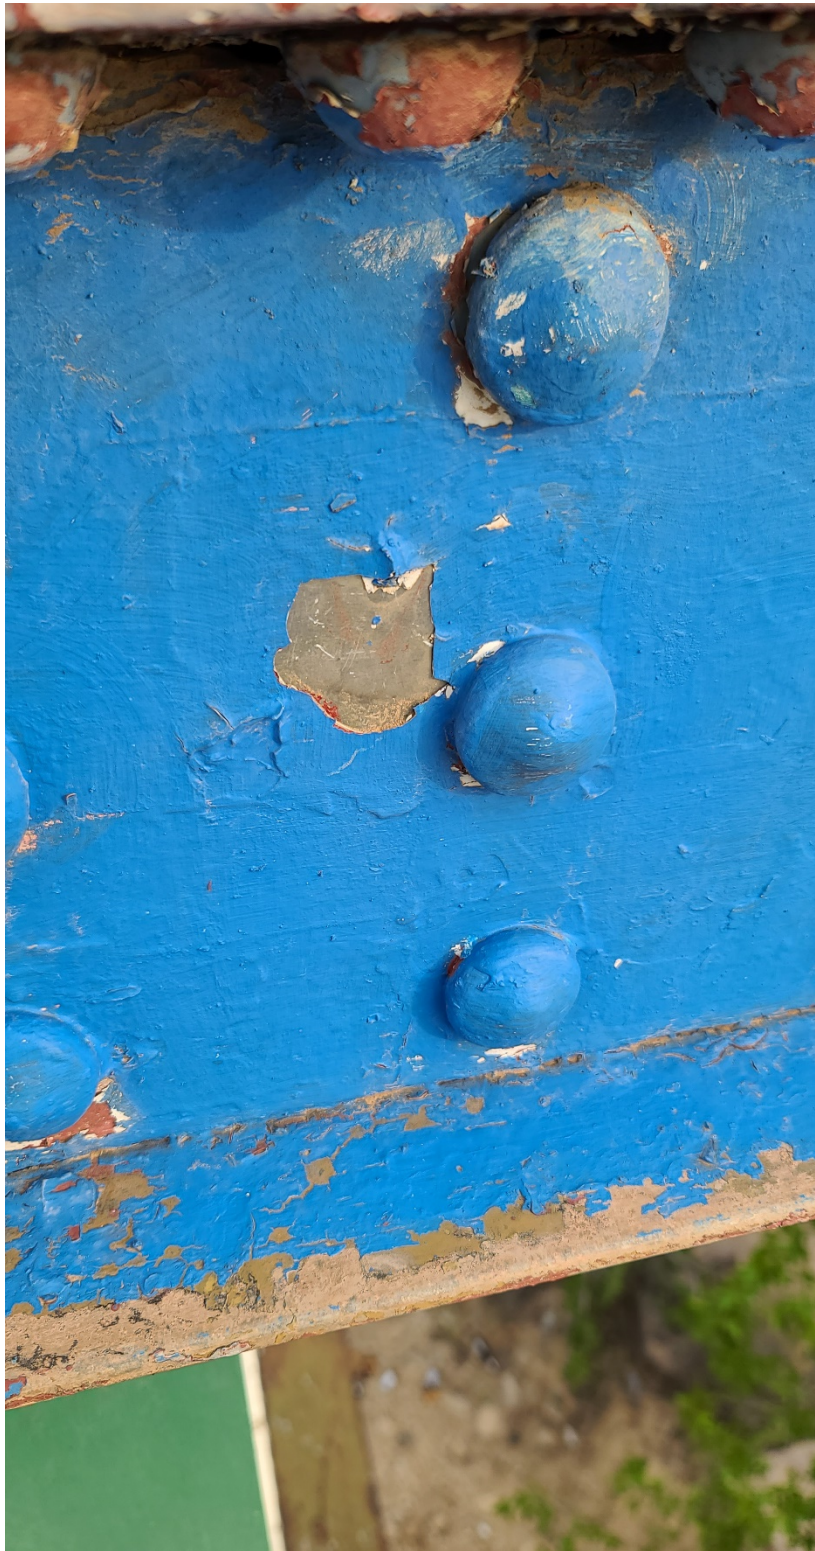
West Rail blue paint at mid span

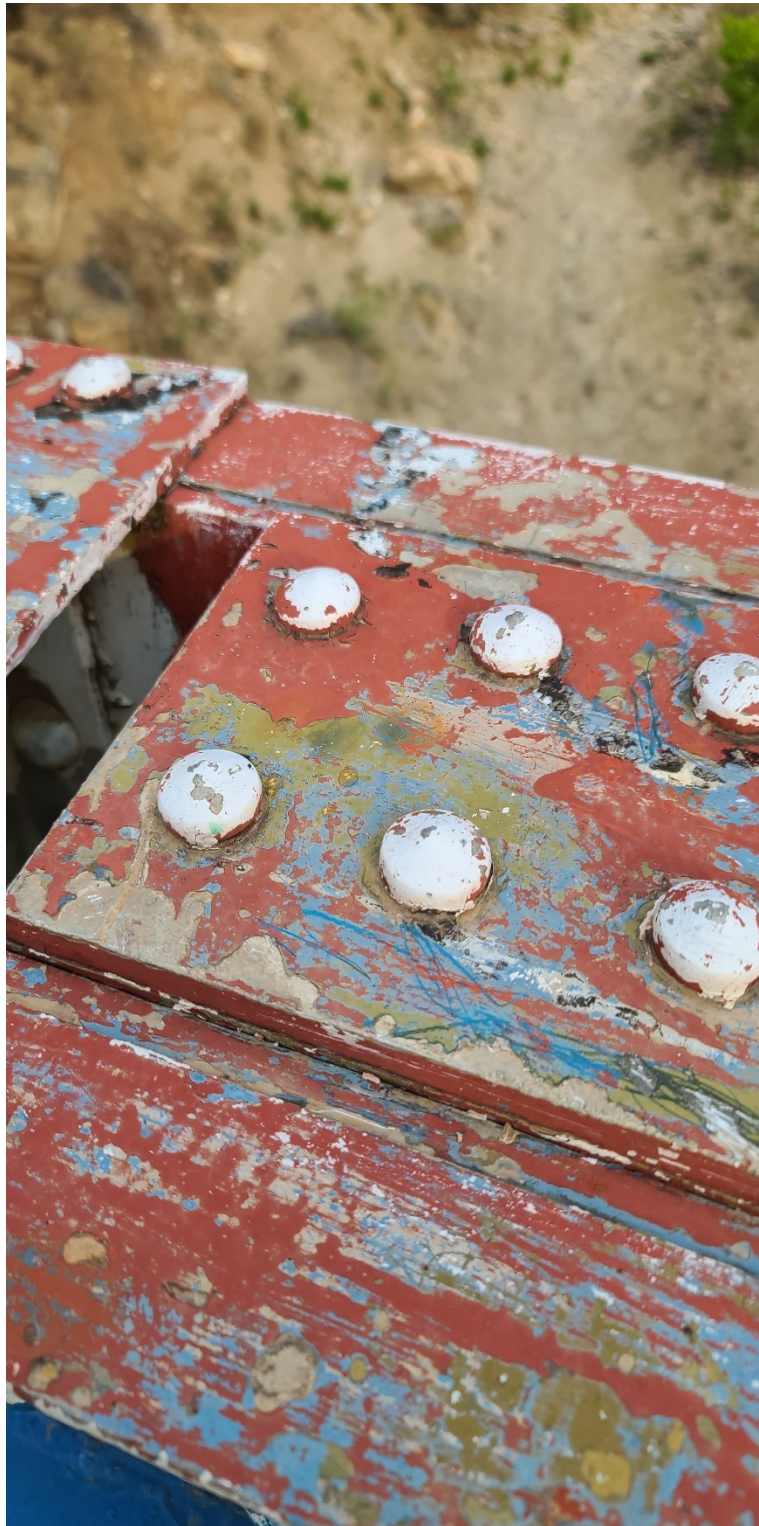
West Rail Red paint at mid span

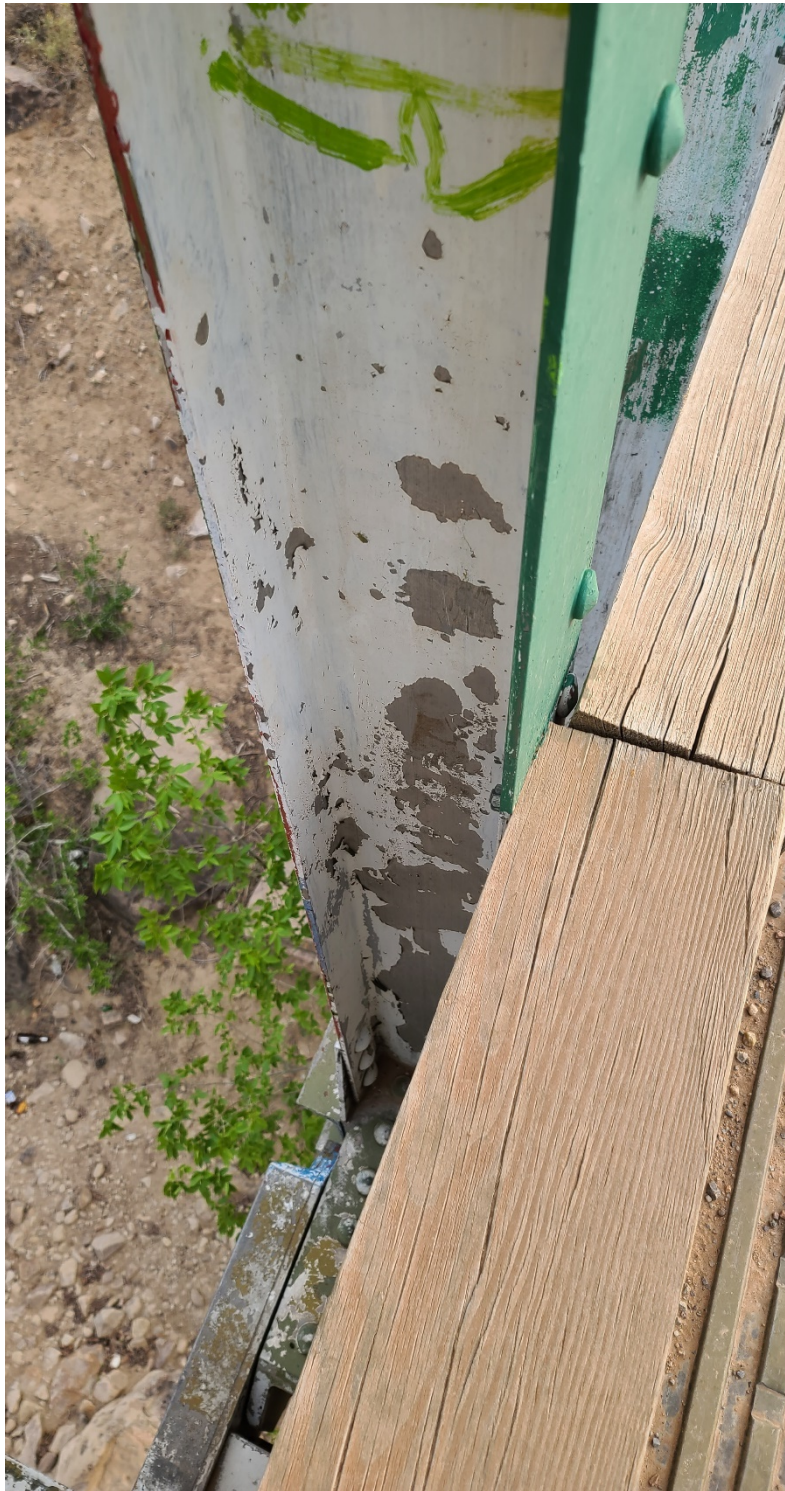
West Rail white paint on verticals

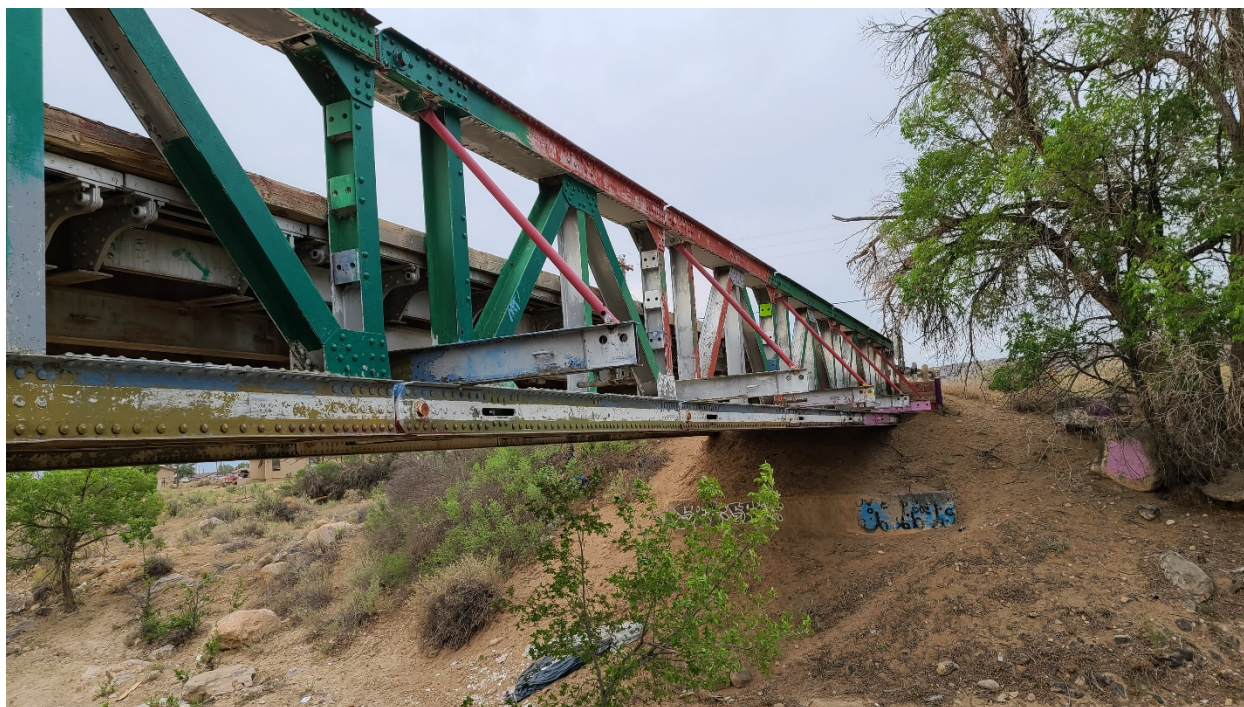
West side showing paint flaking off.
