Request for Proposal (RFP) Bid No: <u>Bid 20-05-2317LE</u> Addendum No. 2

Date:	July 13, 2020
То:	All Proposers
Subject:	Addendum No. 2 Consisting of Twenty-Five (25) Pages
RFP No.:	Bid 20-05-2317LE
Project Name:	N9402(2)1,2&3 Bridge N656 Replacement
Owner:	Navajo Division of Transportation

Structure Inventory and Appraisal Report

Indian Reservation Roads Program RR Bridge Management System **Structure Inventory and Appraisal Sheet**

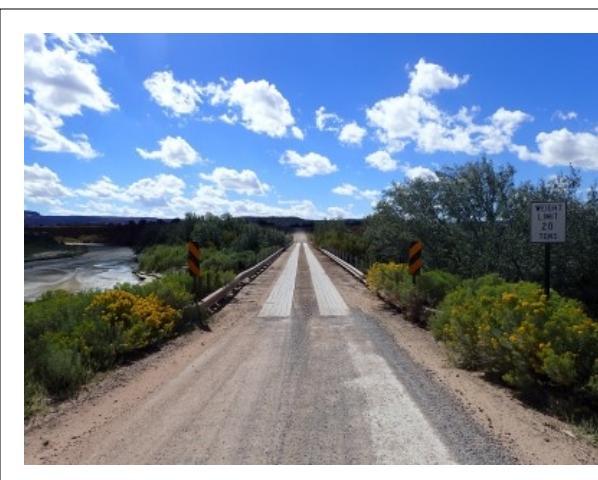
N656_1609_P01 NORTH APPROACH LOOKING SOUTH

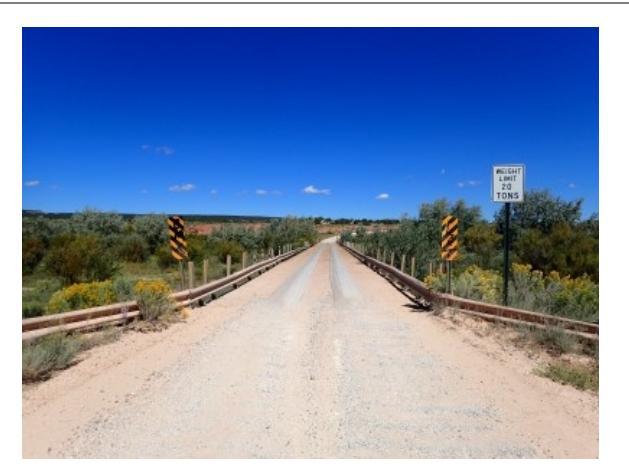
N656_1609_P02 SOUTH APPROACH LOOKING NORTH

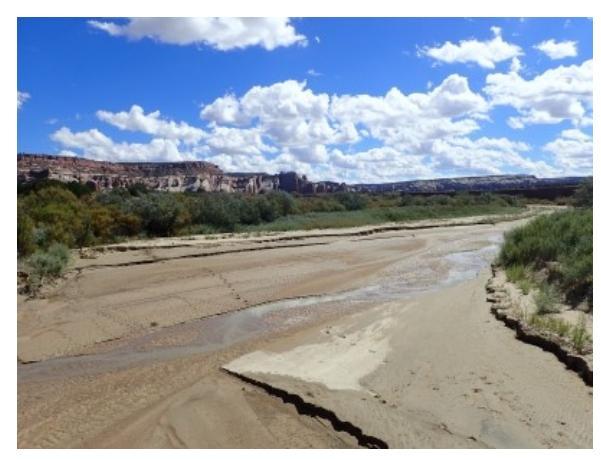
N656_1609_P03 CHANNEL VIEW LOOKING EAST

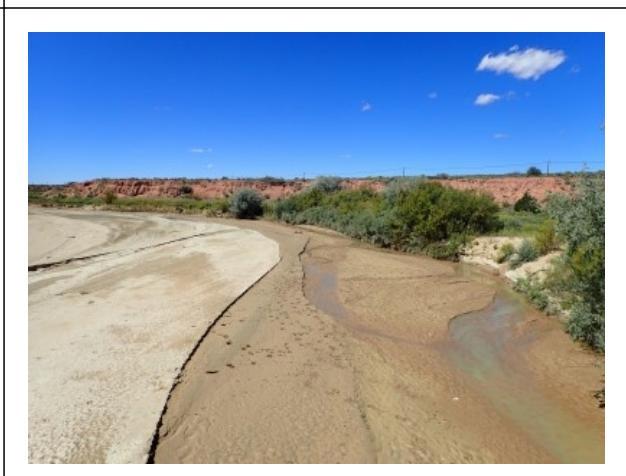
N656_1609_P04 CHANNEL VIEW LOOKING WEST

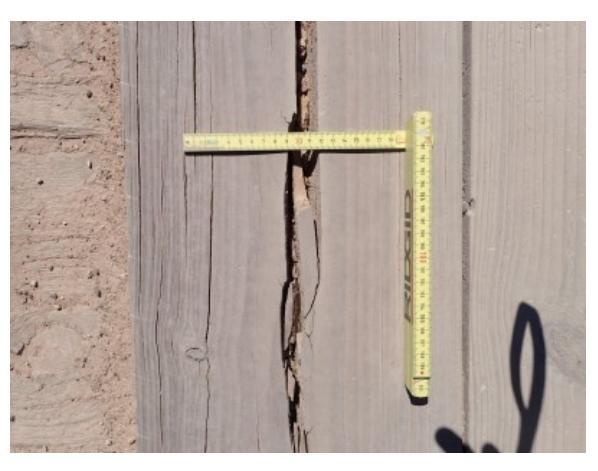
N656_1609_P05 RUNNERS WITH CHECKS UP TO 30MM W

BRIDGE SHOULD BE REPLACED. INSTALL COMPLETE RAIL SYSTEM IF BRIDGE IS NOT SCHEDULED FOR REPLACEMENT. RUNNING PLANKS NEEDS REPAIRED/ REPLACED. REMOVE DEBRIS AT PIERS. INSTALL PROTECTION AT NE EMBANKMENT

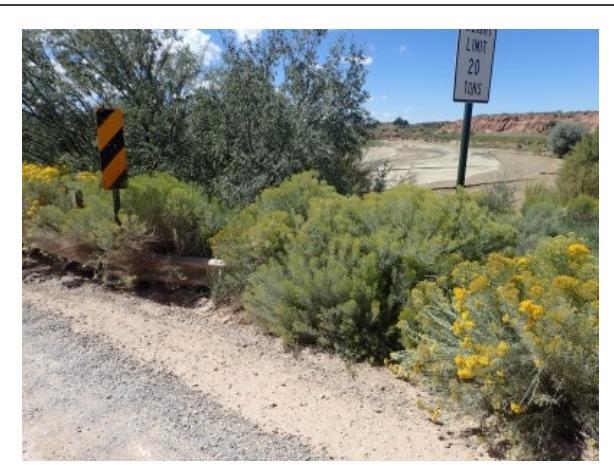
N656_1609_P06 VEGETATION OVERGROWTH AT NW APPROACH RAIL

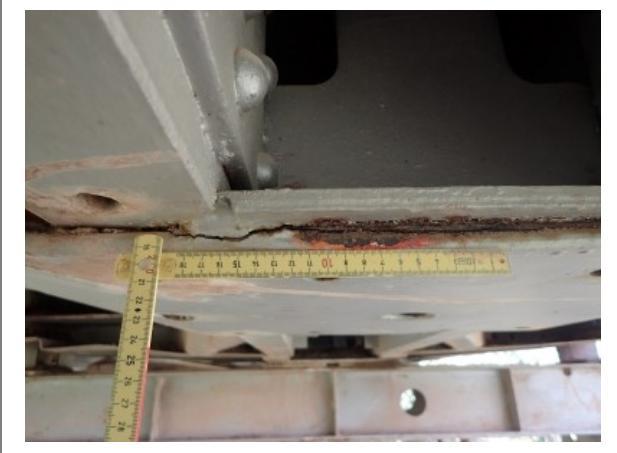
N656_1609_P07 SPAN 1 FLOORBEAM, CRACK IN TACK WELD

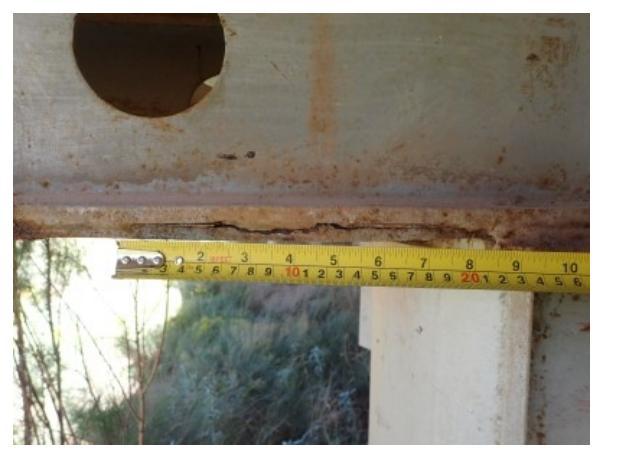
Estimated Co	ost:	\$0
1019				There is a stored image:	YES	Is Urgent:	NO
	Description:	PIER 1, SOUTH 2MM W. SIMIL DUE TO PACK	FACE, CRACK W AR CRACKED WI RUST.	ITH PACK RUST ABO ELDS AT PIERS 6 AND	VE COLUMN 8 ABOVE T	N 2, 0.2M L HE COLUM	X INS
					Estimated Co	ost:	\$0
1020				There is a stored image:	YES	Is Urgent:	NO
	Description:	LONGITUDINA	L RUNNERS HAV	E CHECKS UP TO 30N	/M W X 35M	IM D.	
					Estimated Co	ost:	\$0
		To Total estin	otal estimated urgen nated non-urgent ma	at maintenance costs for r aintenance costs for previ	new deficienci ious deficienc	es: ies:	\$0 \$0

N656_1609_P09 CRACK AT PIER 1 WITH PACK RUST
