**Lybrook MDWCA Tank Inspection Reports, August 2016**

## WATER TANK INSPECTION REPORT

**Town, City, Agency:** Lybrook Water Users Association      **Date:** 8/20/2016

**Tank#:** #2 North      **Tank Capacity:** 50K gallon      **Dia.:** 24      **High:** 16

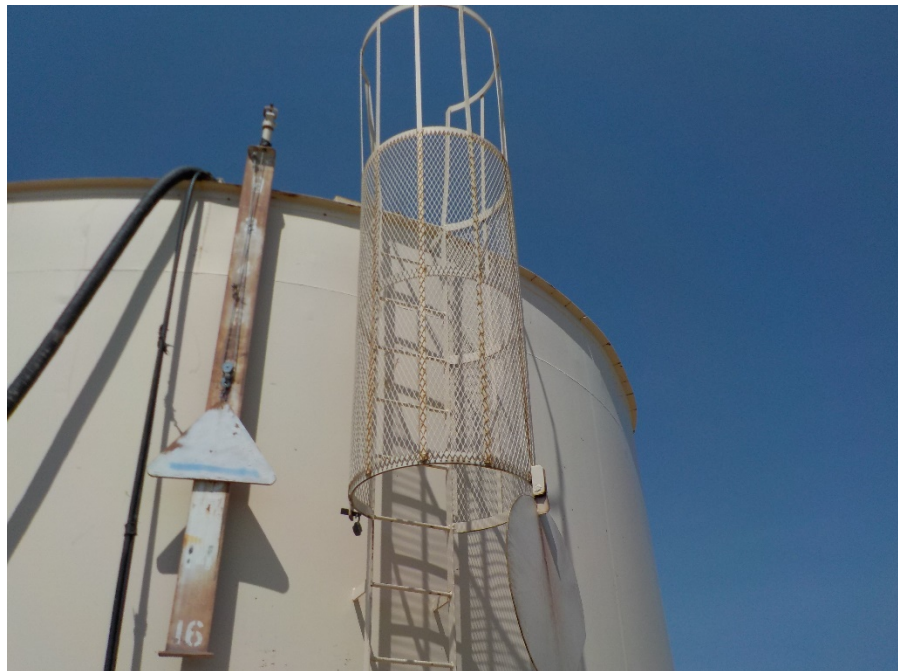
**Current Water Level:** 12      **Tank Location:** Lybrook North Tank
