# **Geotechnical Engineering Report**

N11 Roadway Alignment  
Crownpoint, New Mexico  
19-517-00054

Subject: **Supplemental Pavement Design and Foundation Study  
N11 Roadway Alignment  
Mariano Lake, New Mexico**

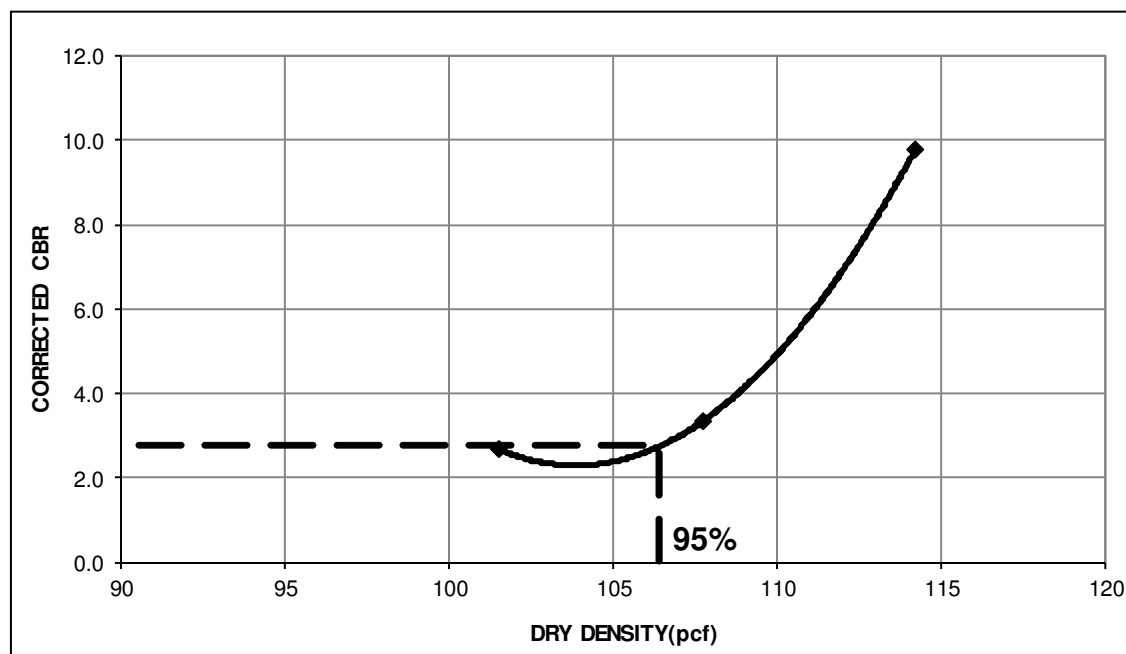
**Optimum Moisture:** 13.0

**Density at 95% of Maximum Density:** 106.4

**Corrected CBR at 0.1 Penetration:** 2.8

| Sample Source | Penetration (inches) | Density at 95% of Max. Density (lb/ft <sup>3</sup> ) | Optimum Moisture (%) | California Bearing Ratio, CBR (%) |
|---|---|--|---|---|
| B-04 and C-02 | 0.1 | 106.4 | 13.0 | 2.8 |
