GEOTECHNICAL INVESTIGATION
Sage Memorial Hospital
Junction of Hwy 268 and Hwy 191
Ganado, Arizona

IGES Job No. 01276-002

July 10, 2009

Geotechnical Investigation
Sage Memorial Hospital
Junction of Hwy 268 and Hwy 191
Ganado, Arizona

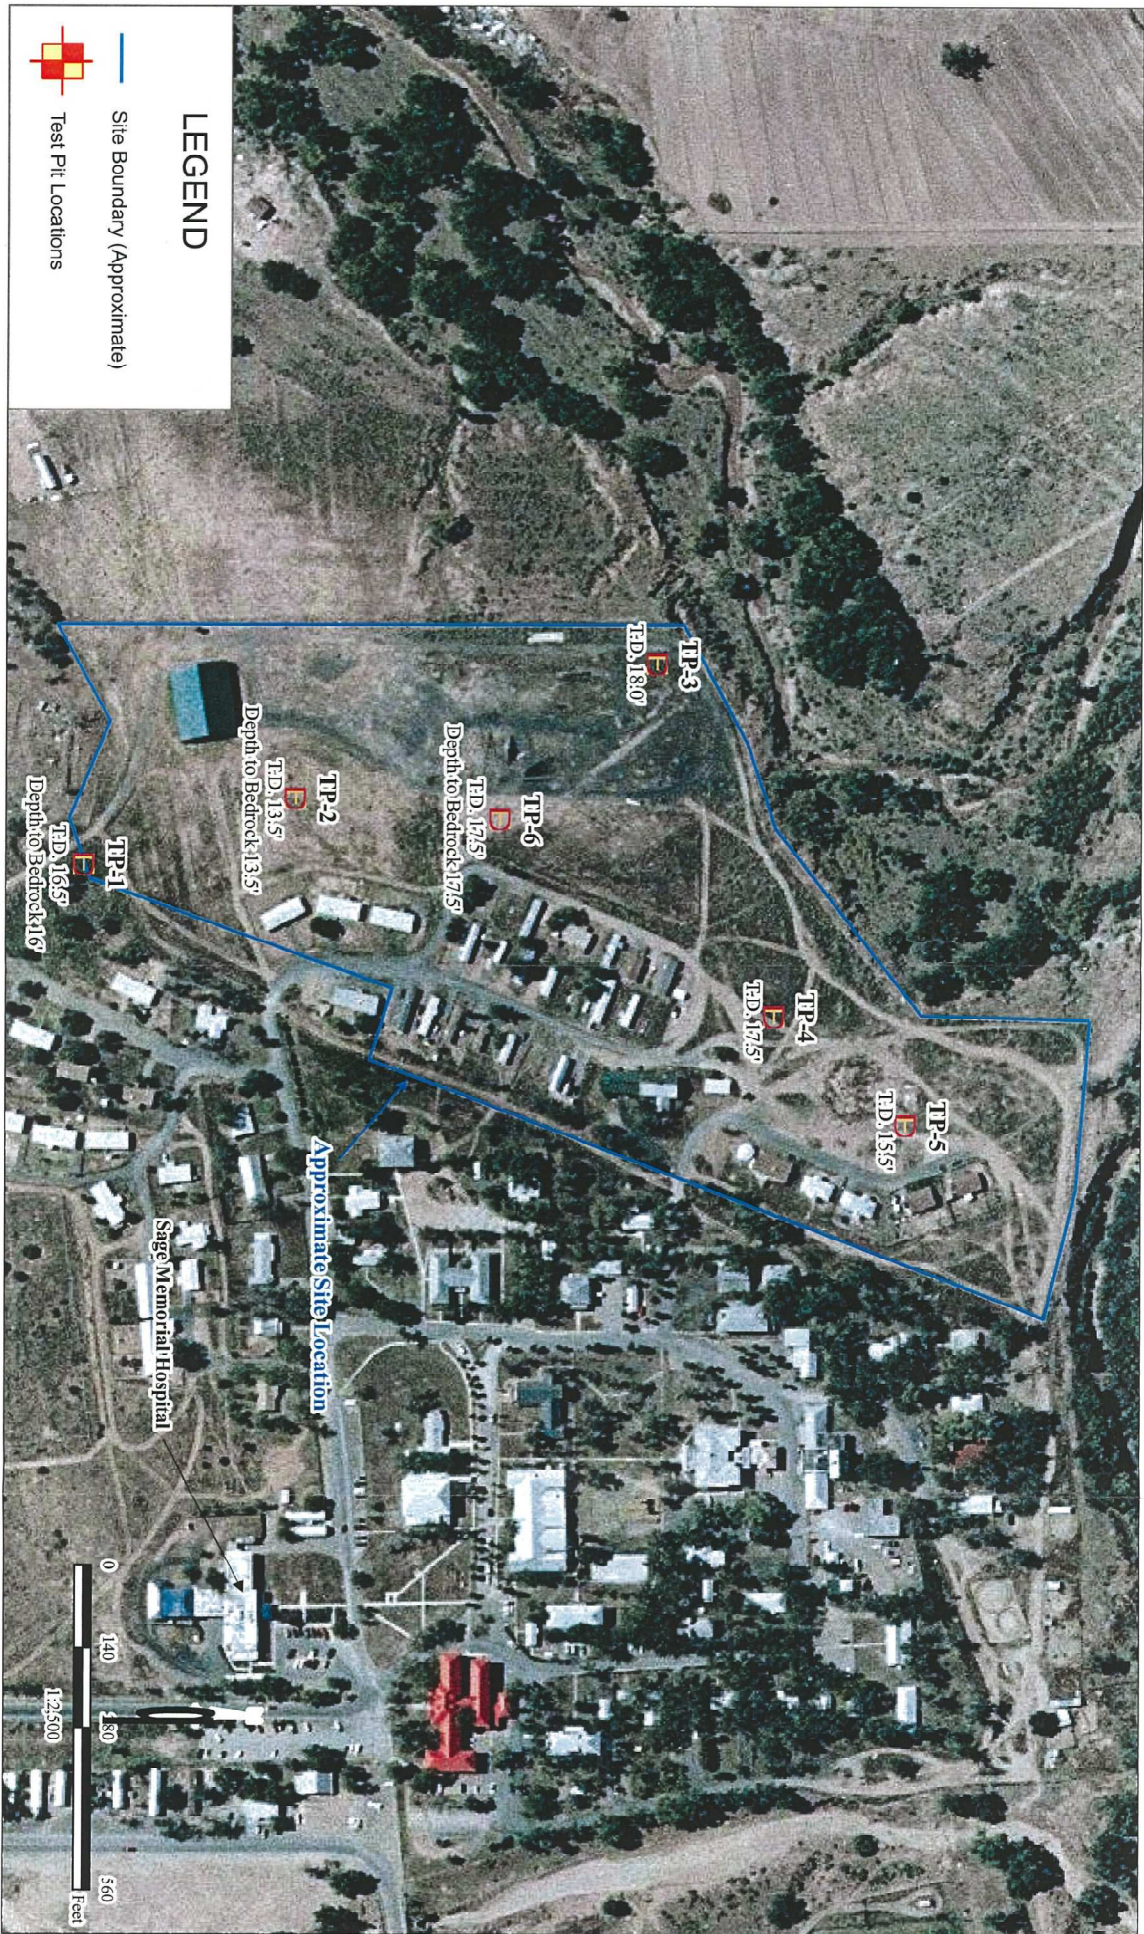
LEGEND

Site Boundary (Approximate)
