# CHILCHINBETO COMMUNITY SYSTEM PUMPHOUSE GEOTECHNICAL ENGINEERING REPORT

Project No.: US0036583.2607

**Re: Geotechnical Engineering Report  
Chilchinbeto Community System Pumphouse  
Chilchinbeto, Arizona**

# Geotechnical Engineering Report

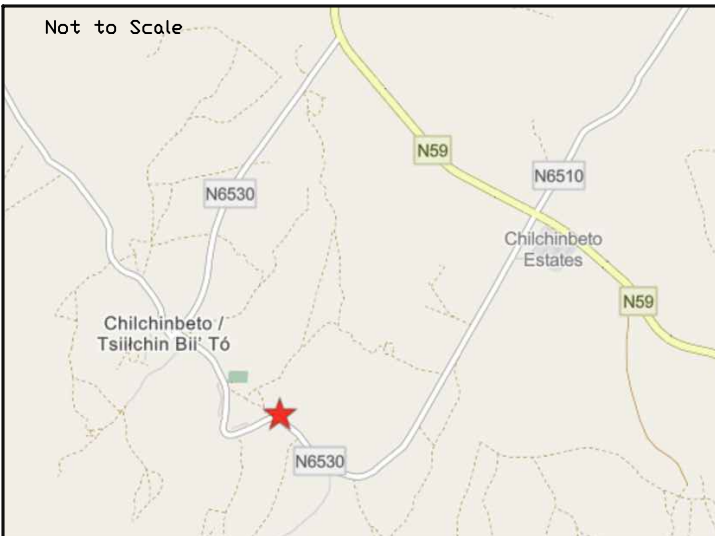
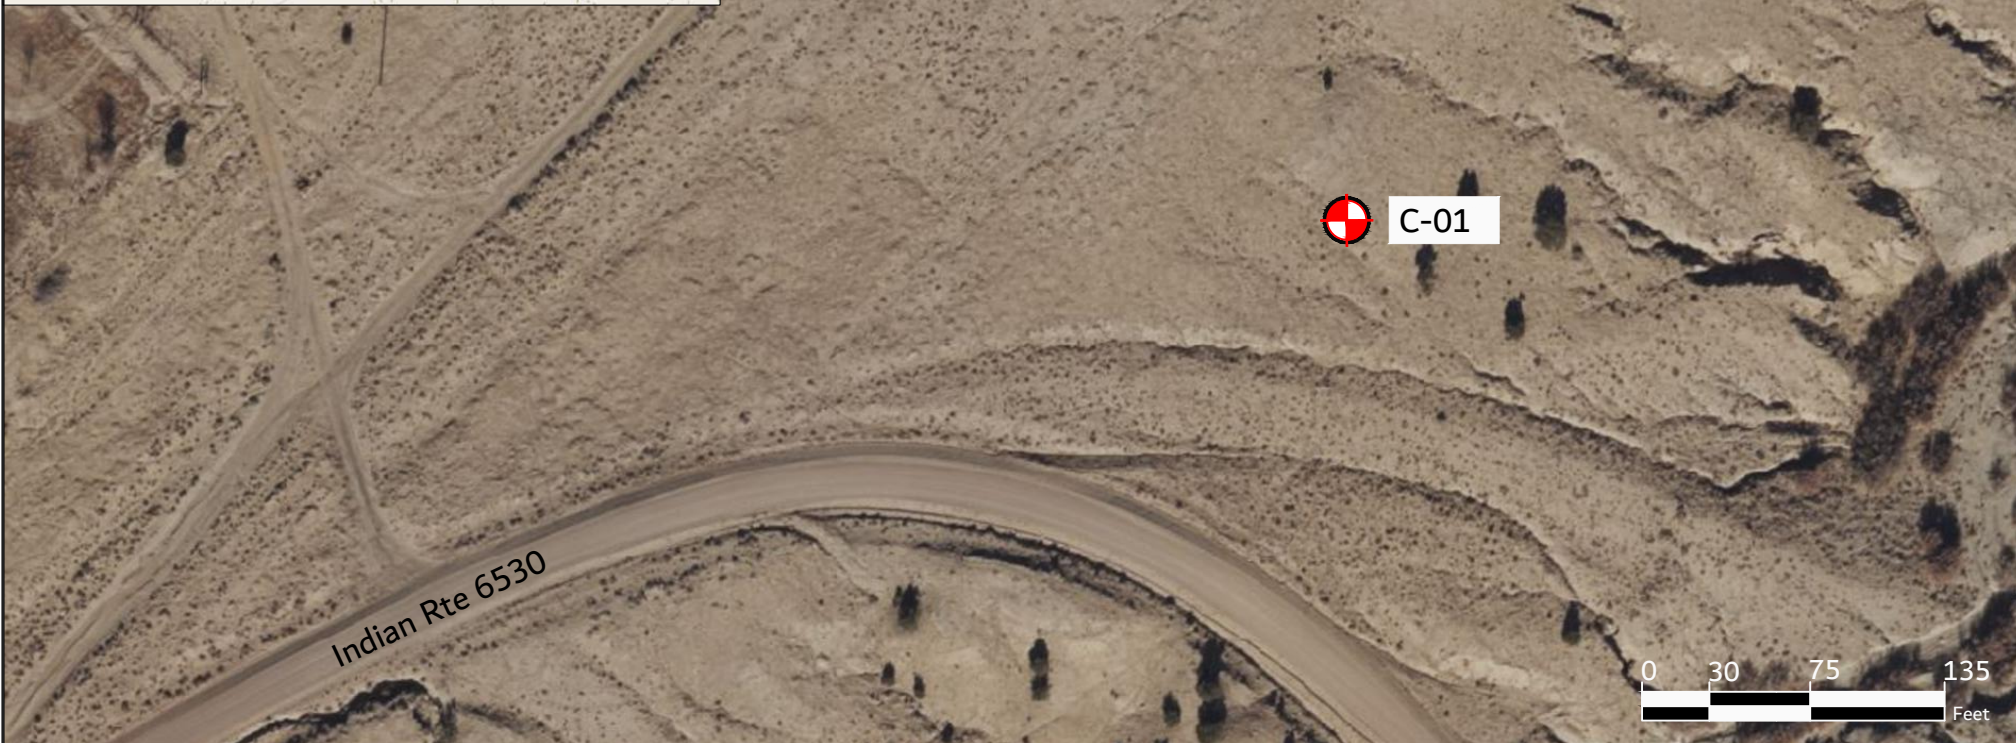
Not to Scale

FIELD EXPLORATION PROCEDURES, SITE  
LOCATION AND EXPLORATION PLAN,  
BORING LOGS

The enclosed Boring Logs describe the vertical sequence of soils and materials encountered in each boring, based primarily on field classifications and supported by subsequent laboratory examination and testing. Where a soil contact was observed to be gradational, boring logs indicate the average contact depth. Where a soil type changed between sample intervals, we inferred the contact depth. The boring logs also graphically indicate the blow count, sample type, sample number, and approximate depth of each soil sample obtained from the borings, as well as any laboratory tests performed on these soil samples. If any groundwater was encountered in a borehole, the approximate groundwater depth is depicted on the boring log. Groundwater depth estimates are typically based on the moisture content of soil samples, the wetted height on the drilling rods, and the water level measured in the borehole after the auger has been extracted.

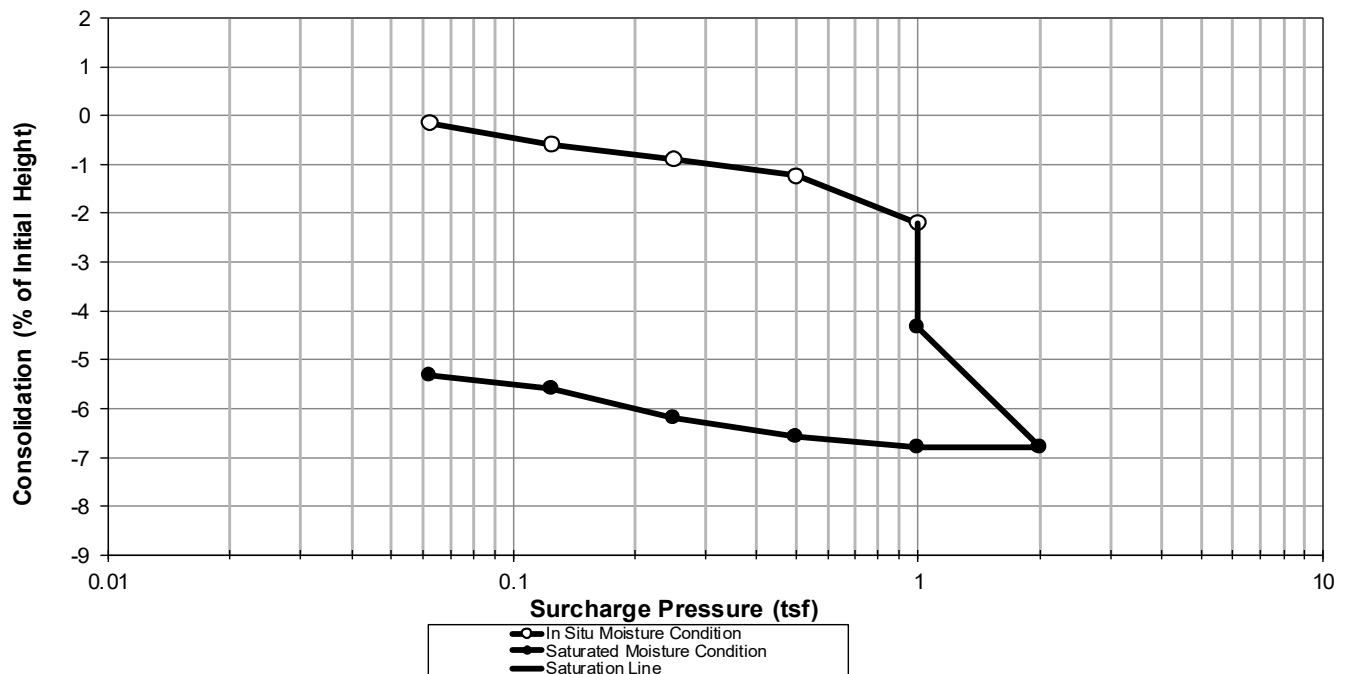
**Initial Volume (cu.in.):** 4.60  
**Initial Moisture (%):** 7.2%  
**Initial Dry Density (pcf):** 97.0  
**Initial Degree of Saturation:** 27%  
**Initial Void Ratio:** 0.71  
**Estimated Specific Gravity:** 2.651  
**Soil Classification:**

**Final Volume (cu.in.):** 4.36  
**Final Moisture (%):** 22.7%  
**Final Dry Density (pcf):** 102.3  
**Final Degree Saturation:** 98%  
**Final Void Ratio:** 0.62  
**Saturated at:** 1 tsf  
**Consolidation at Max Load:** 6.80%

C-01 @ 7.5 feet	-2.3%	Collapsed upon wetting
C-01 @ 15.0 feet	-2.1%	Collapsed upon wetting

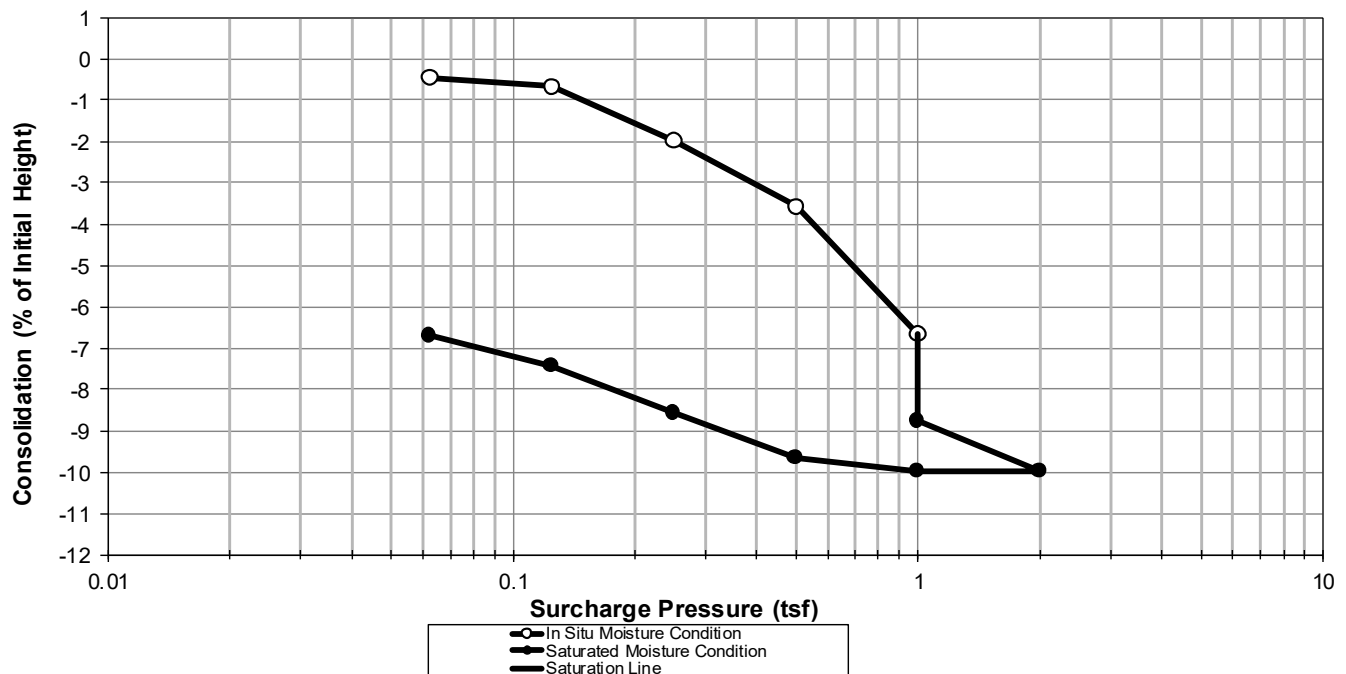
**Initial Volume (cu.in.):** 4.60  
**Initial Moisture (%):** 5.7%  
**Initial Dry Density (pcf):** 104.6  
**Initial Degree of Saturation:** 26%  
**Initial Void Ratio:** 0.58  
**Estimated Specific Gravity:** 2.651  
**Soil Classification:**

**Final Volume (cu.in.):** 4.31  
**Final Moisture (%):** 21.0%  
**Final Dry Density (pcf):** 111.6  
**Final Degree Saturation:** 116%  
**Final Void Ratio:** 0.48  
**Saturated at:** 1 tsf  
**Consolidation at Max Load:** 9.98%

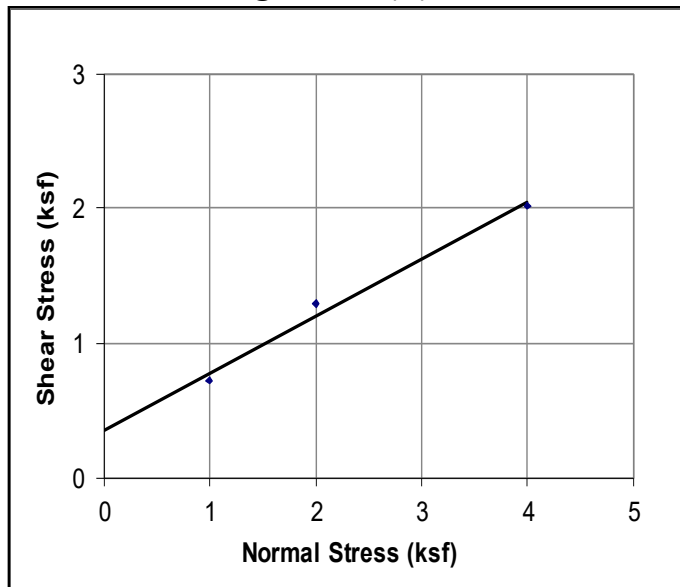
#### Direct Shear Test of Soils Under Consolidated Drained Conditions (ASTM D3080-11)

Direct Shear Point Number:	1	2	3
Initial Diameter of specimen (in.):	2.42	2.42	2.42
Initial Thickness of specimen (in.):	1.00	1.00	1.00
Dry Mass of Specimen (g):	113.6	114.9	111.8
Initial Moisture (%):	10.1%	12.5%	12.1%
Initial Wet Density (pcf):	103.6	107.1	103.8
Initial Dry Density (pcf):	94.1	95.2	92.6
Final Thickness of specimen (in.):	0.97	0.95	0.96
Final Moisture (%):	22.6%	24.8%	22.5%
Final Wet Density (pcf):	118.9	125.1	118.1
Final Dry Density (pcf):	96.9	100.2	96.5
Normal Stress (ksf):	1.00	2.00	4.00
Maximum Shearing Stress (ksf):	0.728	1.292	2.026
Vertical Deformation @ Max Shear (in.):	-0.015	-0.024	-0.019
Horizontal Deformation @ Max Shear (in.):	0.150	0.225	0.195

Humboldt Direct Shear Apparatus, Model HM-5760

Sample	Depth (ft)	Internal Friction Angle, $\phi$ (deg.)
C-01	7.5	22.9
C-01	15.0	38.9

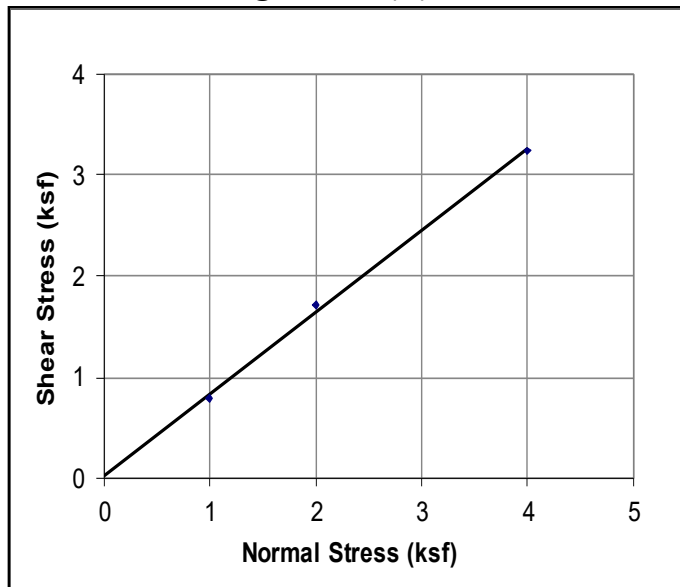
#### Direct Shear Test of Soils Under Consolidated Drained Conditions (ASTM D3080-11)

Direct Shear Point Number:	1	2	3
Initial Diameter of specimen (in.):	2.42	2.42	2.42
Initial Thickness of specimen (in.):	1.00	1.00	1.00
Dry Mass of Specimen (g):	126.9	121.6	135.3
Initial Moisture (%):	7.2%	5.9%	7.0%
Initial Wet Density (pcf):	112.7	106.7	119.9
Initial Dry Density (pcf):	105.1	100.7	112.1
Final Thickness of specimen (in.):	1.02	1.00	1.01
Final Moisture (%):	17.3%	19.5%	15.4%
Final Wet Density (pcf):	120.5	120.2	127.7
Final Dry Density (pcf):	102.7	100.6	110.6
Normal Stress (ksf):	1.00	2.00	4.00
Maximum Shearing Stress (ksf):	0.788	1.718	3.235
Vertical Deformation @ Max Shear (in.):	-0.003	-0.003	0.003
Horizontal Deformation @ Max Shear (in.):	0.075	0.105	0.120

Humboldt Direct Shear Apparatus, Model HM-5760
